# Manhole Inspection Summary

Manhole # S13II\_046MH

Insp Date: **2/24/09 11:16 AM**

**Location** Address: **REAR 2918 NORTH AVE**

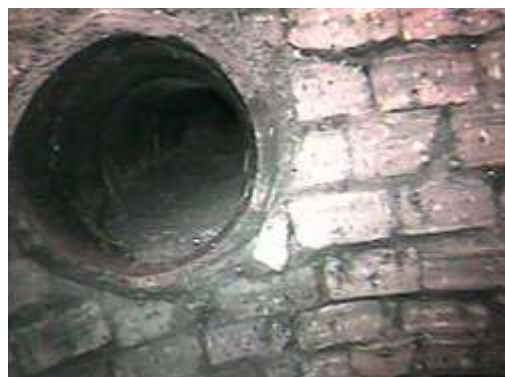
UNKNOWN

POSSIBLR OLD THROUGHPIPE

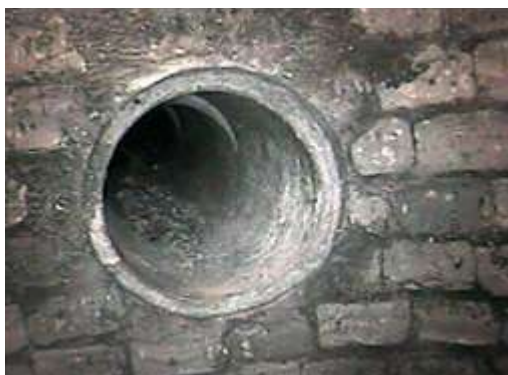
UNKNOWN

POSSIBLE OLD THROUGHPIPE

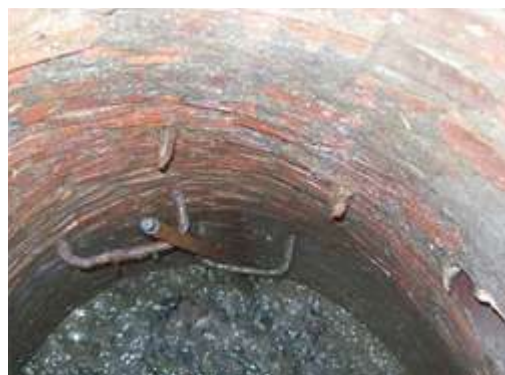
Defect 1

**Steps** Count: **3** Missing: **1** ☒ **Corroded**

CORRODED STEP

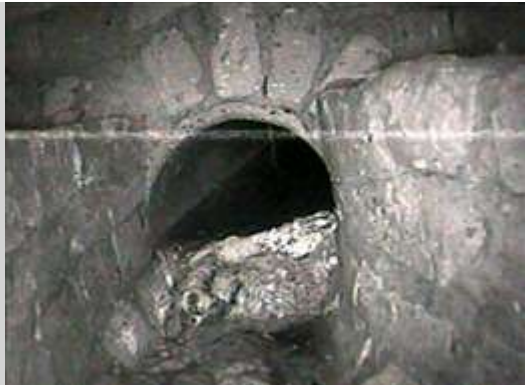
9 O'Clock Inflow

Deposits: ☐ None ☐ Mud ☐ Sludge ☒ **Debris** ☐ Grease

Silt Depth: **2** (in.) Deposits Extent: **Medium**
